Hepworth-Pawlak
Geotechnical, Inc.
10302 South Progress Way
Parker, Colorado 80134
Phone: 303-841-7119
Fax: 303-841-7556
www.hpgeotech.com

May 1, 2014

Subject: Inclinometer Readings
Spires Broadmoor Debris Dams
Colorado Springs, Colorado

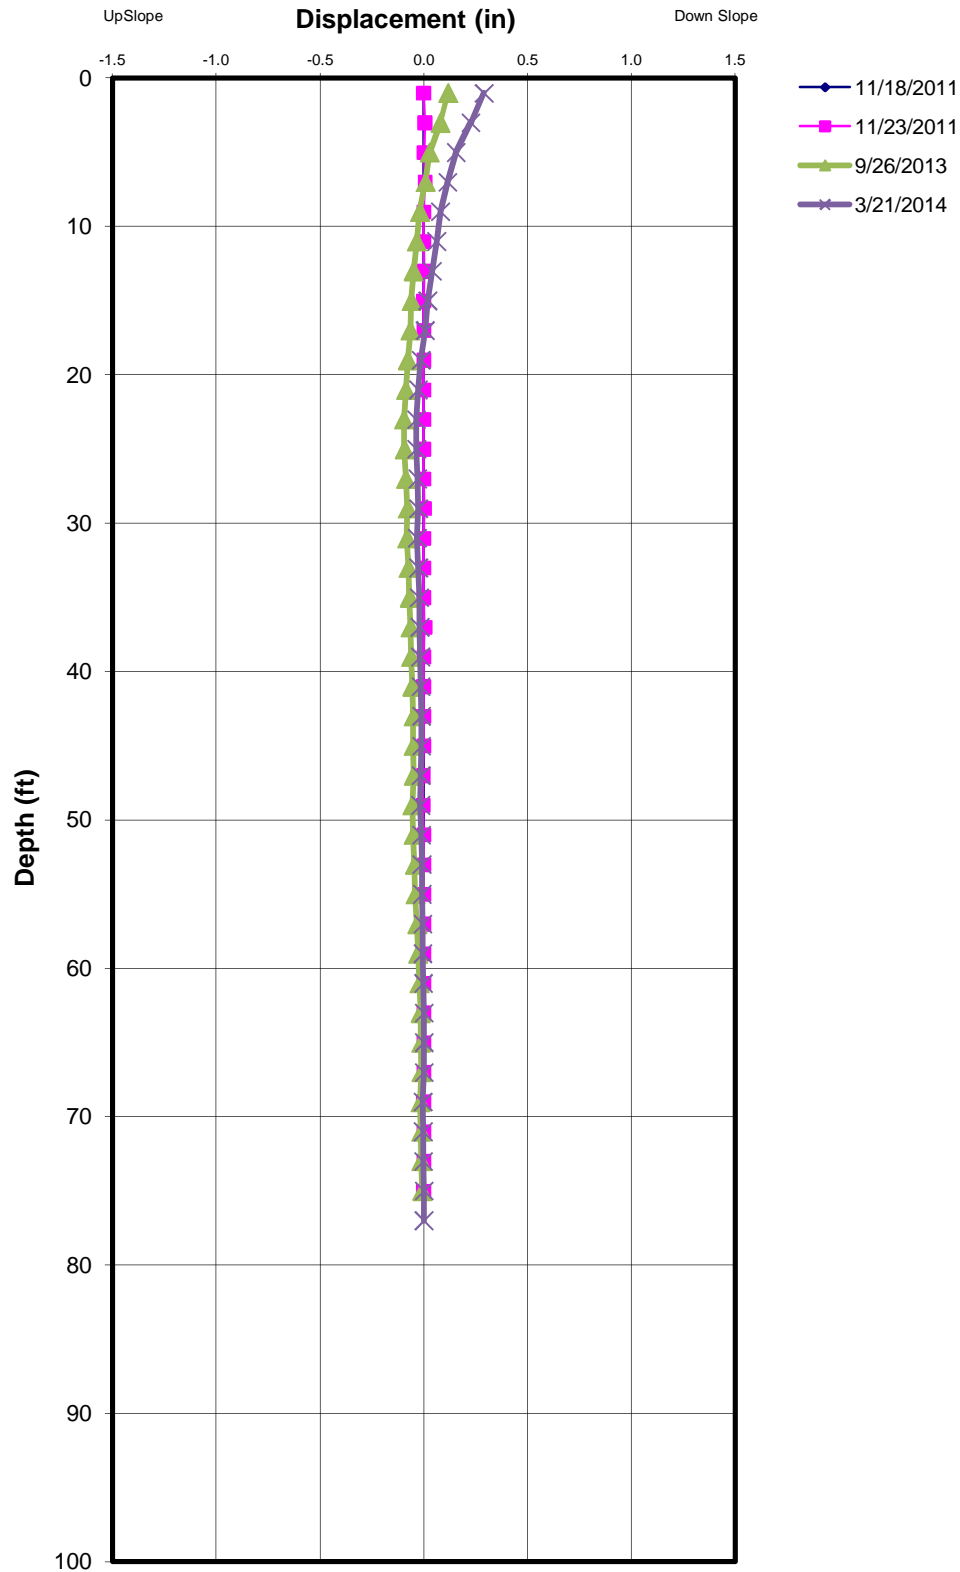
South Dam Inclinator A-Axis

It appears that some movement has occurred at these locations. Future readings are recommended to establish a trend.
