Site Inspection Report
The Spires Broadmoor Drainage Homeowner's Association
Drainageway Inspections
Colorado Springs, Colorado

Kiowa Project No. 13060

November 7, 2013

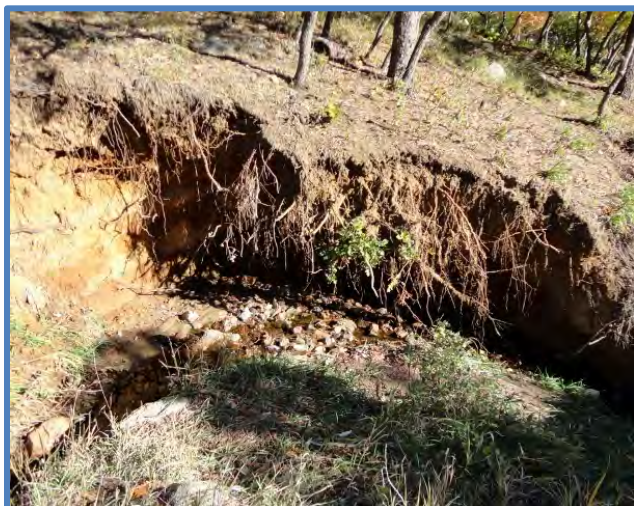
Photo 1A North: Major erosion and under cutting along Lot 1, Stonecliff Filing No. 6 [525 Paisley Drive] and Lot 13 Stonecliff Filing No. 6A [515 Paisley Drive] immediately east of the Air Force property where drainage comes onto property. *Action: Repairs Recommended. Protect bank from eroding further.*

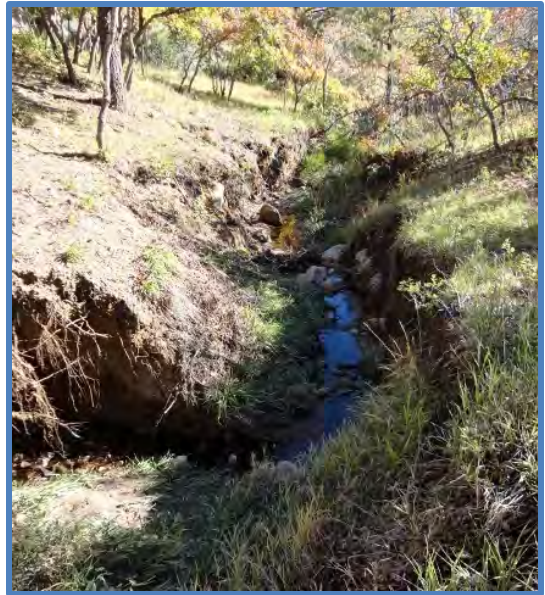
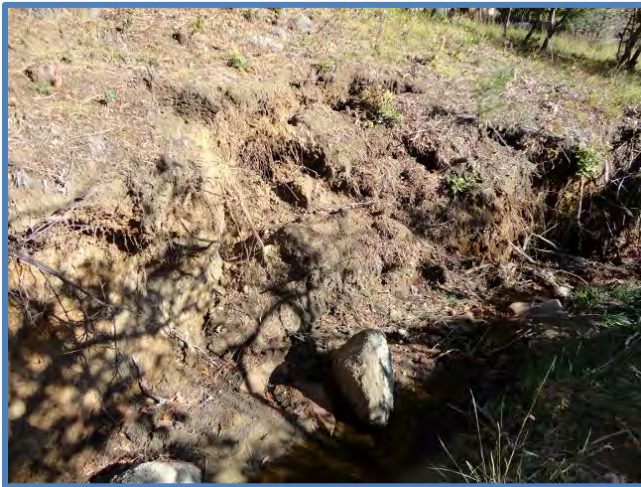
Photo 1B North: Moderate erosion along the side slopes of the bank (Lot 1, Stonecliff Filing No. 6 and Lot 13 Stonecliff Filing No. 6A east of the Air Force property). *Action: Repairs Suggested. Stabilize side slopes and channel.*

Photo 1C North: Moderate erosion along the side slopes of the bank (Lot 1, Stonecliff Filing No. 6 and Lot 13 Stonecliff Filing No. 6A east of the Air Force property). *Action: Repairs Suggested. Stabilize channel side slopes.*

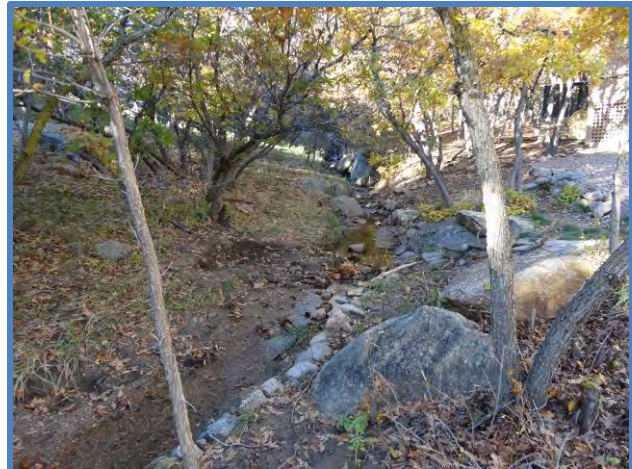
Photo 2A Southwest: Minor erosion on south side of ditch behind Lot 109 Boulders Broadmoor #2 [332 Darlington Way]. *Action: Good Condition. No action recommended.*

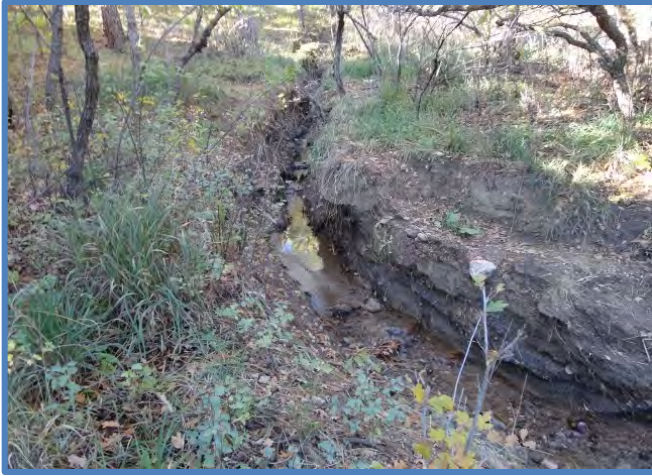
Photo 3A Southwest: Moderate to minor erosion in the drainageway behind Lot 81 Boulders Broadmoor #2 [390 Paisley Drive]. *Action: Good Condition. The sideslopes of eroded areas could be flattened if concerned about drop off.*

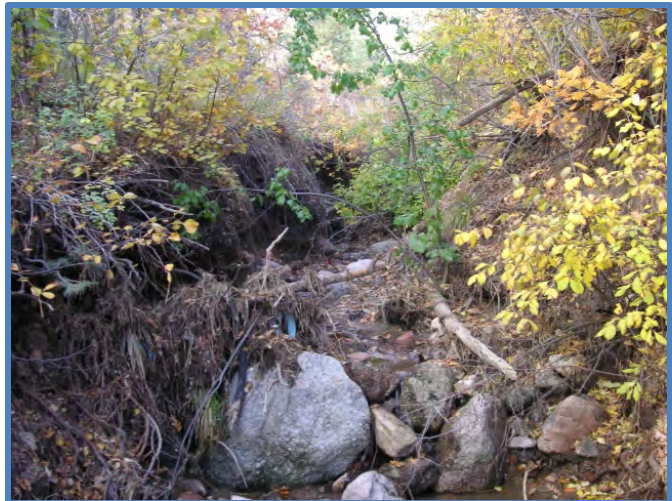
Photo 4A West: Significant erosion along the drainageway behind Lots 1, 2 and 19 Spires Broadmoor Filing No.2 resulting in vertical side slopes.

Action: Debris/Sediment Removal at a minimum and Monitor Condition of the eroded vertical side slopes.

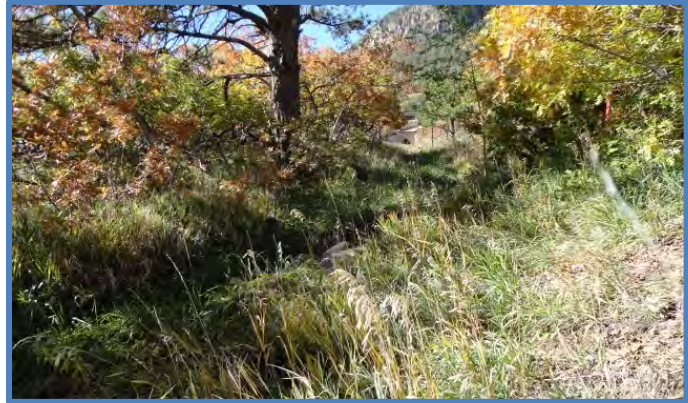
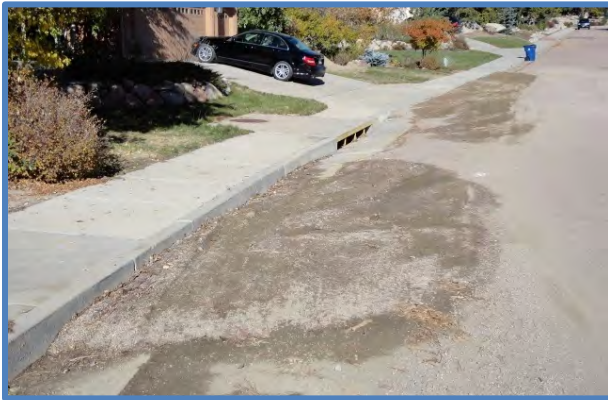
Photo 5A Southwest: Minor erosion along drainageway side slopes. Drainageway in good condition. *Action: Good Condition. No action recommended.*

Photo 5C Northwest: Silt in roadway in front of Lot 8 Stonecliff Filing No. 6 [605 Paisley Drive]. Silt appears to be coming from Lots 9 and 10 [615 & 635 Paisley Drive] to the north. Refer to Drainage 6 description. The silt has been removed from the street since the photo was taken. *Action: No action required in Drainage 5, refer to Drainage 6 description.*

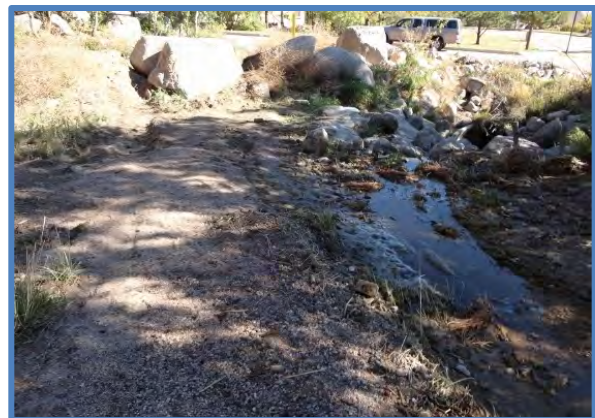
Photo 6A Northeast: A swale should be cut through this easement to direct flows to the culvert. The location of existing utilities in the easement will need to be determined to verify the location and size of a swale. *Action: Repairs Recommended. Construct a swale to the existing culvert at Paisley.*

Action: Repairs Recommended. The repairs should include defining a drainage path to the culvert inlet at Paisley Drive, constructing a swale for the northwest leg of the drainage (see below) through Lot 10 and stabilizing the southwest swale.

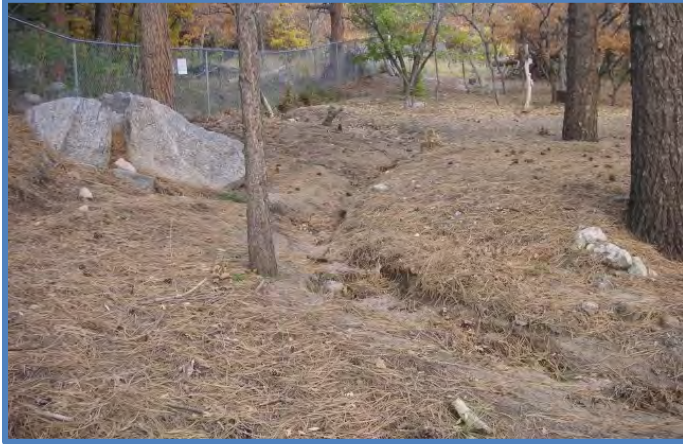
Photo 6B Northwest: The existing swale is too small to convey the flows from the upstream area. *Action: Repairs Recommended. A swale and berm should be cut through backyard of Lot 10 to direct flows into the easement and towards the existing culvert at Paisley.*

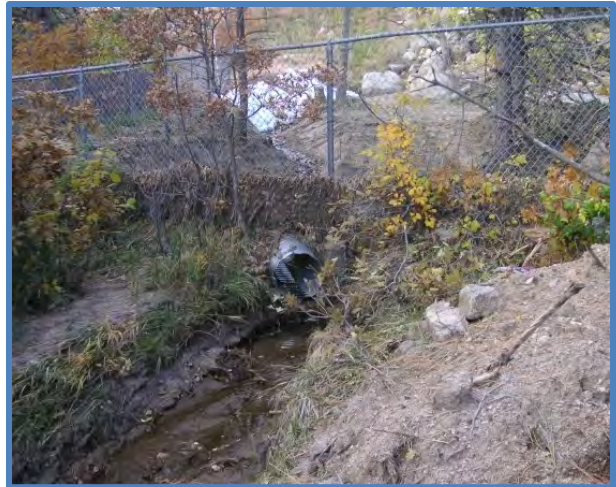
Photo 6C Southwest: A swale with sandbags and a culvert were installed upstream of the fence on the NORAD property. *Action: Repairs Recommended. The swale downstream of the NORAD property should be protected from future erosion.*

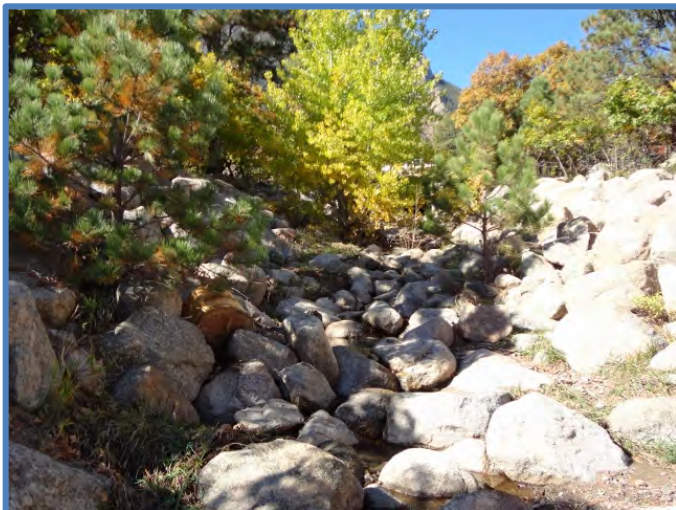
Photo 7A West: Small pine trees and a clump of aspens exist in the channel along the back of Lot 59 [5748 Adrienne Court]. *Action: Monitor Condition. Monitor the trees and condition to avoid accumulation of debris along trees that would reduce the flow capacity of the drainageway.*

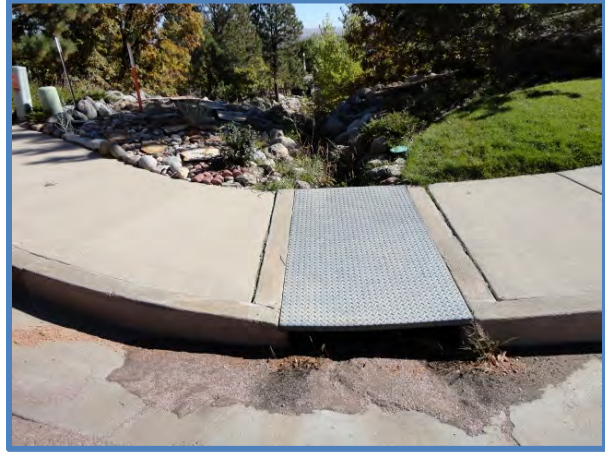
Photo 7C East: Silt in the sidewalk chase between Lots 58 and 59 Boulders Broadmoor Filing No. 2 [5736 & 5748 Adrienne Court]. *Action: Good Condition. No action required, unless it continues to be an issue. Contact City if it continues to be an issue.*

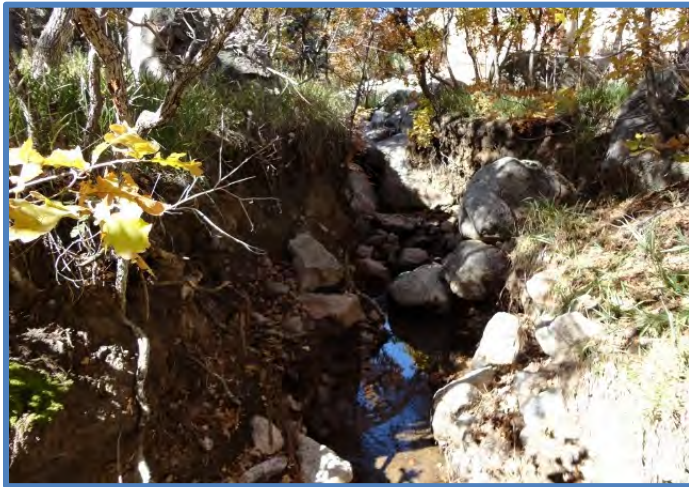
Photo 8A West: Significant erosion downstream of Buttermere Drive resulting in 6-foot +/- vertical sideslopes. *Action: Repairs Recommended. Stabilize existing side slopes and drainage bottom.*

Action: Repairs Recommended. Repair areas where erosion has created 6-foot +/- vertical banks in Lots 82 and 83. Monitor condition of drainageway for remainder of drainageway.

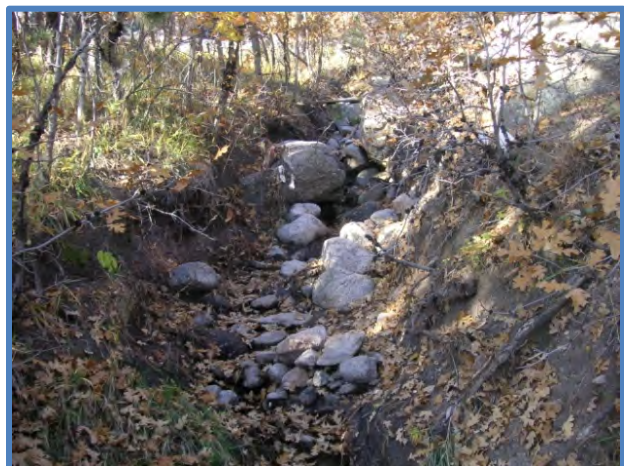
Photo 8B East: Moderate erosion between Lots 54 and 55. *Action: Monitor Condition of drainageway and side slopes.*

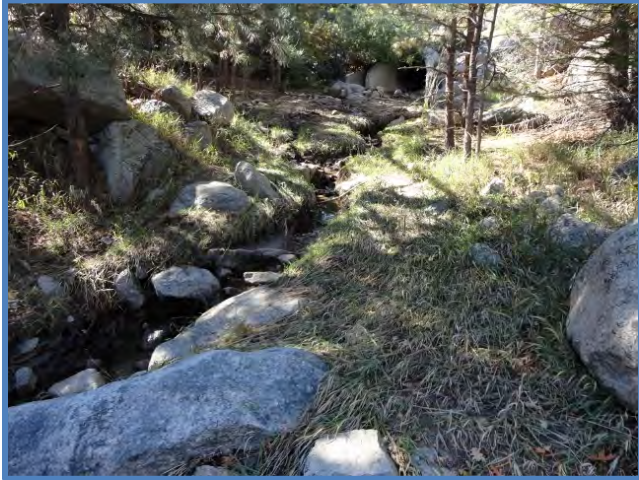
Photo 9A Southwest: Minor erosion in a few areas along Lot 19 [730 Paisley Drive]. *Action: Good Condition. No action necessary.*

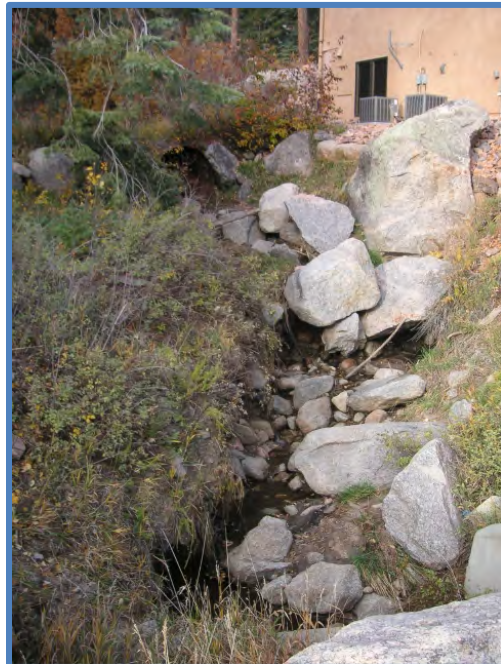
Photo 10A Southeast: Significant erosion downstream of the large boulders shown in the photo along the side slopes and bottom. *Action: Repairs Recommended. Repairs to stabilize channel bottom and side slopes upstream of Paisley culvert.*

Action: Repairs Recommended. Repairs to stabilize area between existing culverts to minimize future erosion and protect the building foundation.

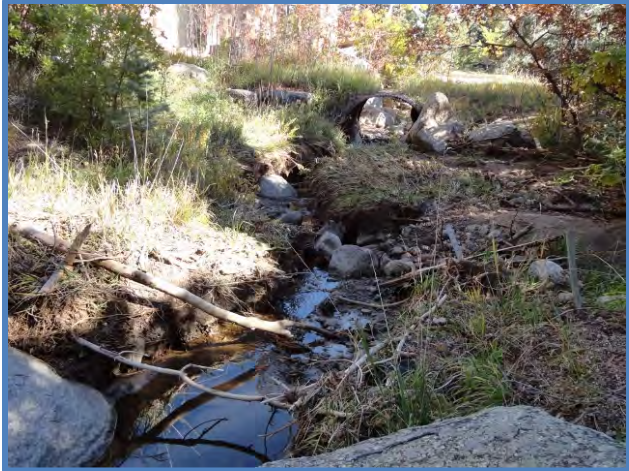
Photo 10B Northeast: Minor erosion between the existing steel culvert and the NORAD property. *Action: Good Condition. No action recommended.*

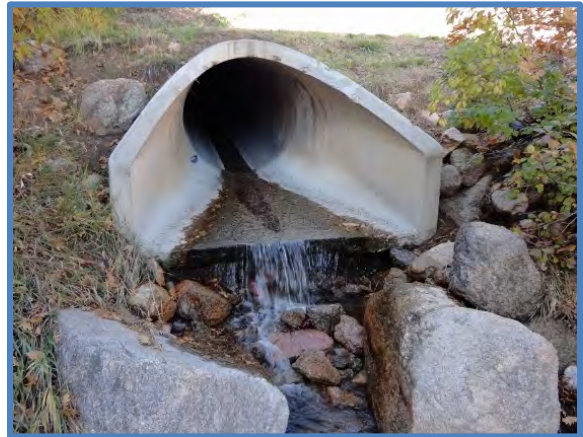
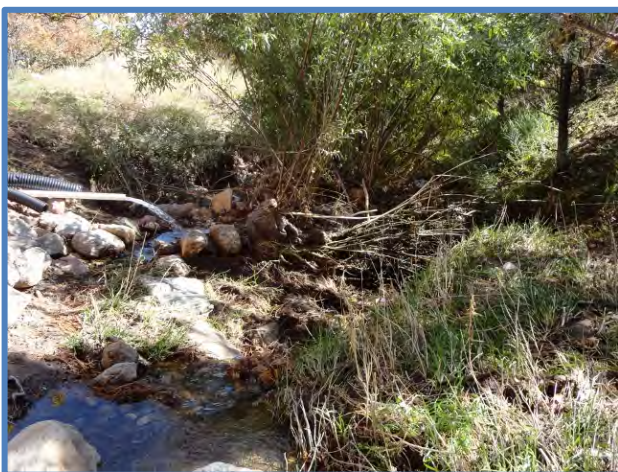
Photo 11A West: Minor undercutting and erosion at flared end section (FES) between Lot 17 Spires Broadmoor Filing No. 1 [210 Balmoral Way], Lots 3 Spires Broadmoor 1-A [220 Balmoral Way]. . *Action: Repairs Suggested. Install riprap at end of flared end section to protect from future erosion and raise drainageway invert to be flush with FES.*

Photo 11B East: Minor erosion and debris at clump of willows between Lot 17 Spires Broadmoor Filing No. 1 [210 Balmoral Way], Lots 3 Spires Broadmoor 1-A [220 Balmoral Way]. *Action: Debris/Sediment removal and Monitor Condition. Remove debris from channel.*

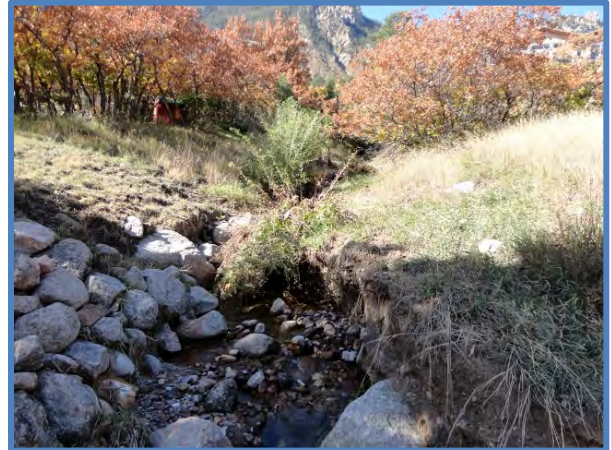
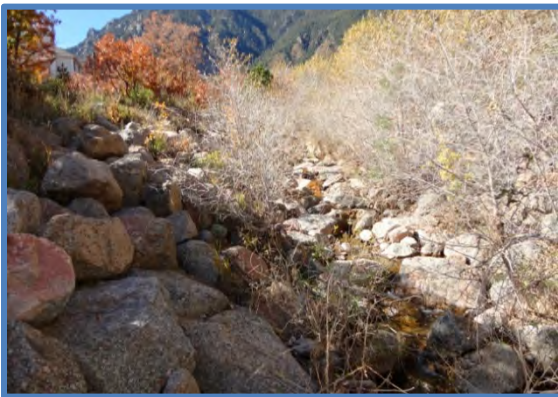
Photo 11D West: Minor erosion in channel behind Lot 5 Spires Broadmoor 1-A [160 Balmoral Way]. *Action: Monitor Condition.*

Photo 11F West: Moderate vegetation in channel behind Lot 1 Country Walk at Broadmoor No. 3 [150 Balmoral Way]. Vegetation may become dense enough to impede decrease flow capacity in drainageway. *Action: Monitor Condition.*

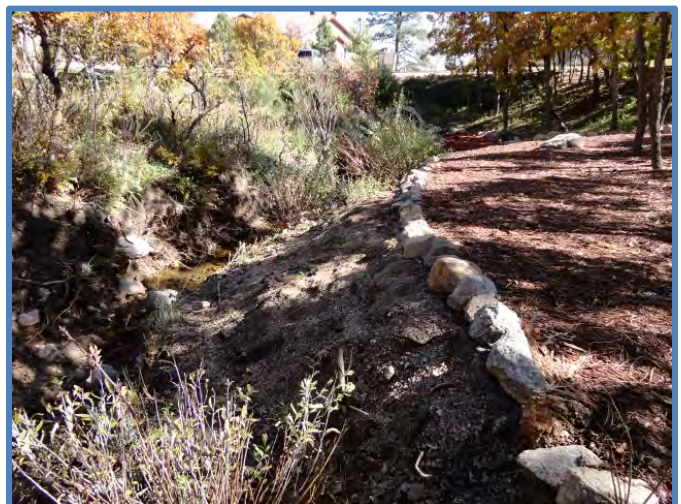
Drainage 12: The drainageway is located along Lots 11 – 21 Spires at Broadmoor Filing No. 1 [281, 275, 225, 214 Balmoral Way, 5904 & 5906 Buttermere Drive, 295 & 285 Ellsworth Street]. Minor erosion and vegetation in channel north of Lot 18 [5904 Buttermere Drive]. The rest of the drainageway is in good condition.

Action: Monitor Condition. Monitor the erosion and vegetation in channel north of Lot 18. The rest of the drainageway is in good condition and no action is recommended.

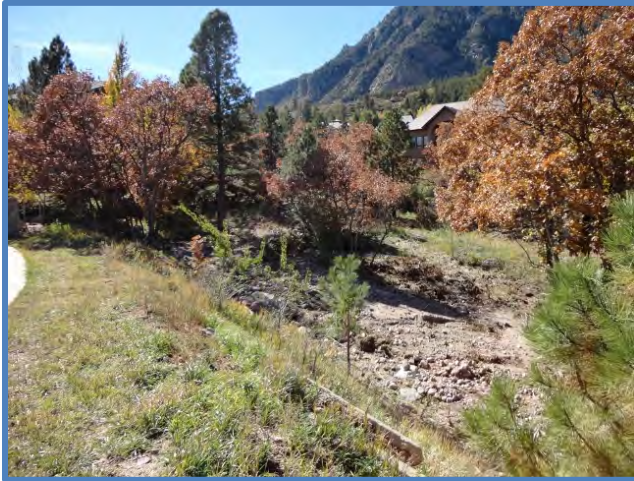
Drainage 14: The drainageway is located in Lots 24, 26 and Tract A of Spires at Broadmoor Filing No. 1 [359 & 367 Irvington Court & 270 Ellsworth Street]. The drainageway is not well defined (20-30-ft wide) at southwest corner of Ellsworth Street and Irvington Court. Some minor erosion along the drainageway.

Action: Good Condition. No action is recommended. The drainageway could be cleaned up to promote vegetation. This would minimize the amount of sediment available to be carried downstream and improve appearance of drainageway near Ellsworth if desired.

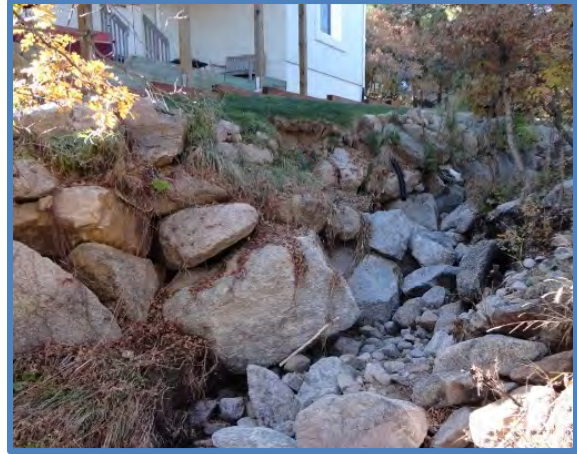
Drainage 18: The drainageway is located along south side of Lots 28, 29, 32, 37, 40, 42 and 43 Boulders Broadmoor Filing No. 1 [5425, 5455, 5475, 5535, 5565, 5585, & 5595 Jarman Street]. The middle section of this drainageway has several areas of erosion where the vertical drop is 3-feet. A couple areas where vegetation is thick or a tree is located in the center of drainageway catching debris. Erosion has occurred near the corner of the house at 120 Ellsworth Street where a portion of the lawn has been lost.

Photo 18I West: Moderate erosion near the rear corner of house at 120 Ellsworth Street. *Action: Repairs Recommended. Protect from future bank erosion at corner of lawn.*

Action: Repairs Recommended. Repair drainageway side slope along 120 Ellsworth Street to protect from future erosion and possibly to restore some of the lost lawn of the land owner. The debris along the drainageway should be removed. Monitor the condition of the eroded banks and monitor the vegetation growth.

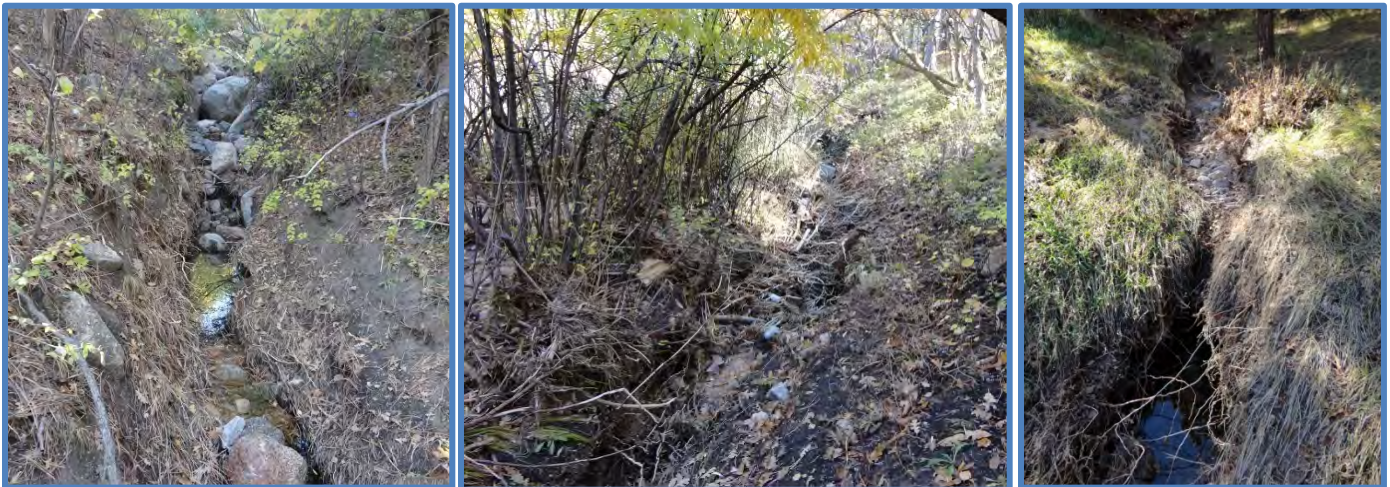
Photo 18B West, 18C East and 18G West: Moderate erosion in channel (3-ft deep). *Action: Debris/Sediment removal from drainageway. Monitor Condition of eroded drainageway sections.*

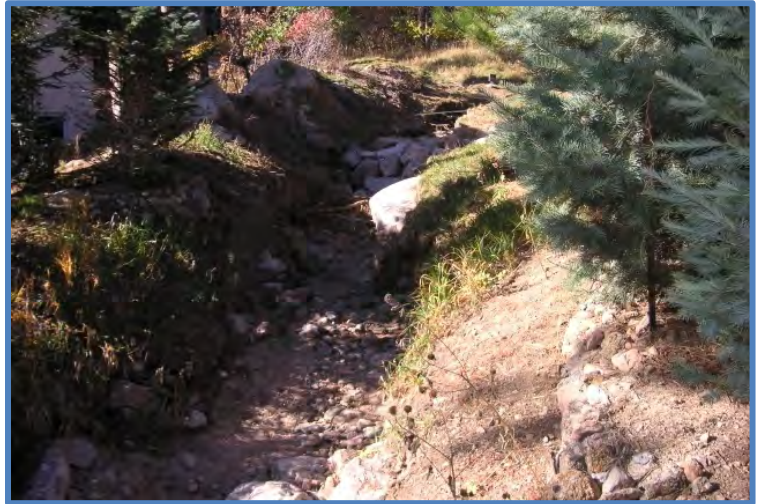
Drainage 19: The drainageway is located along Lots 4 – 6 Boulders Broadmoor Filling No. 1A [5610 Jarman Street, 235 & 245 Stonebeck Lane] and Lots 3 and 4 Boulders Broadmoor Filing No. 1B [255 & 265 Stonebeck Lane]. Moderate erosion (2-4 feet deep) in many locations along the drainageway. The section upstream of the Lot 6 flag is in the most need of attention. A large boulder in the middle of the drainageway adjacent to Lot 4, pushes larger flows into the adjacent side slope creating erosion.

Photo 19A West: Moderate erosion in drainageway and exposed soil berm along berm between drainageway and home. *Action: Repairs Recommended. Stabilize the berm to protect the home at Lot 4 [5610 Jarman Street].*

Action: Repairs Recommended. Repairs along Lot 4 to stabilize the existing drainageway. The soil berm in this area should be stabilized to protect the home at Lot 4 [255 Stonebeck Lane]. Repairs suggested include removing sediment and rocks from existing culvert under the Lot 6 flag [245 Stonebeck Lane] and removing debris from the entire drainageway. Monitor the condition of the eroded slopes along the entire drainageway.

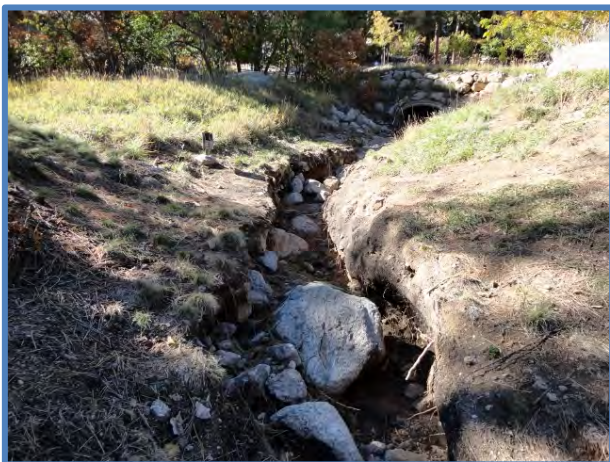
Photo 21A Northwest: Moderate erosion in drainageway to a depth of approximately 2-4 feet in front of Lot 3 [265 Stonebeck Lane]. *Action: Repairs Recommended. Stabilize the drainageway and/or flatten side slopes.*

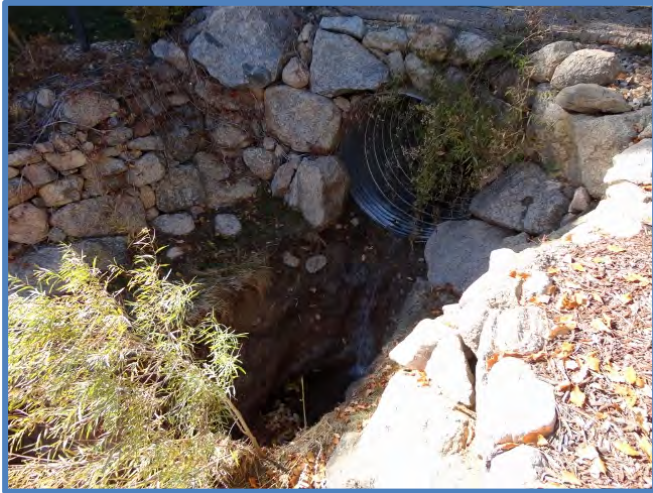
Photo 21C Northwest: Severe erosion at downstream end of private corrugated metal culvert in front of Lot 3 [275 Stonebeck Lane]. *Action: Repairs Recommended. Stabilize ground at outlet of pipe.*

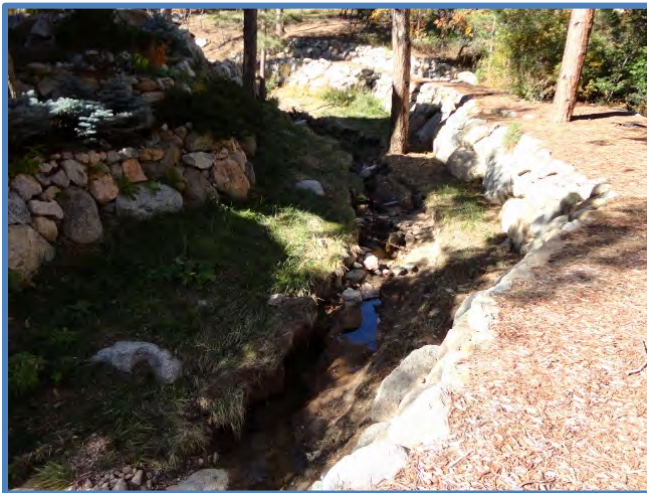
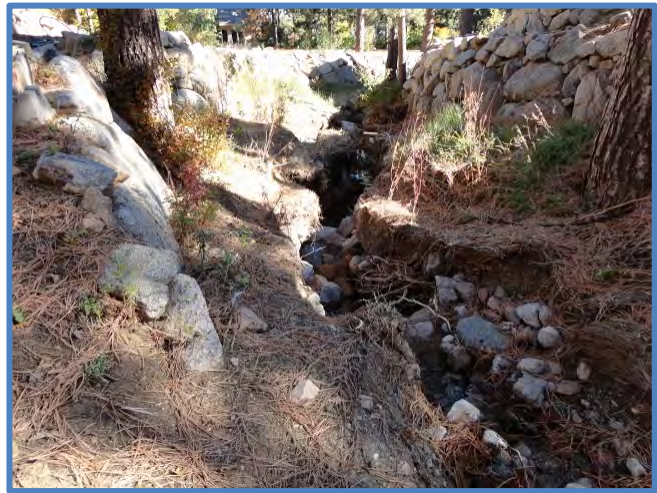
Photo 21D Northwest and 21E Southeast: Moderate erosion (3 – 4 feet deep) along section of drainageway upstream of CMP at Lot 3 [275 Stonebeck Lane]. *Action: Repairs Recommended. Stabilize ground in drainageway between the boulder side walls.*

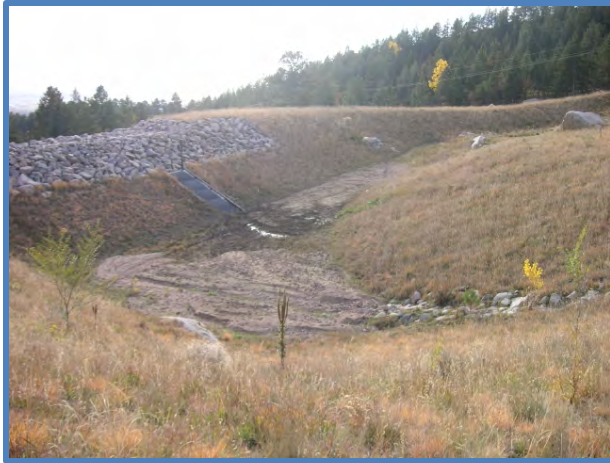
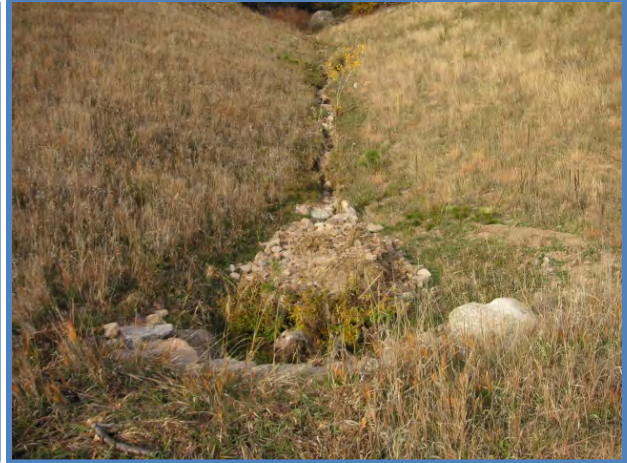
Drainage 23: South Debris Basin. The basin incurred minimal erosion and appears to have functioned as designed. Approximately 24 inches of silt has accumulated in the bottom. The swale directing flows down the northwest corner of the debris basin does not include riprap and has moderate erosion.

Action: Debris/Sediment Removal Only. Remove the sediment from the bottom of the basin. Remove sediment and debris from upstream end of culvert on northwest side. Monitor condition of erosion in northeast swale.

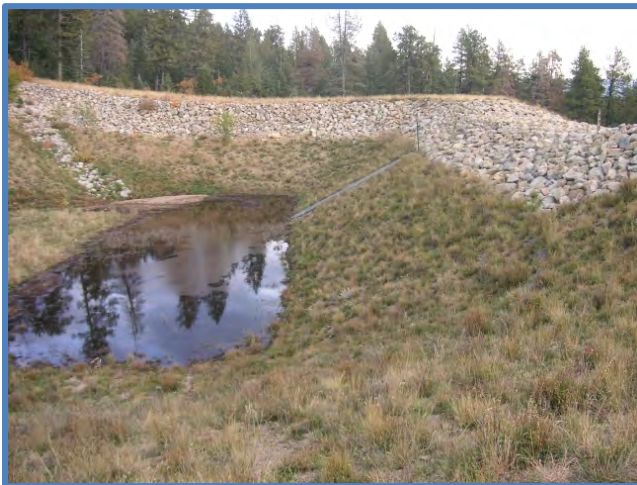
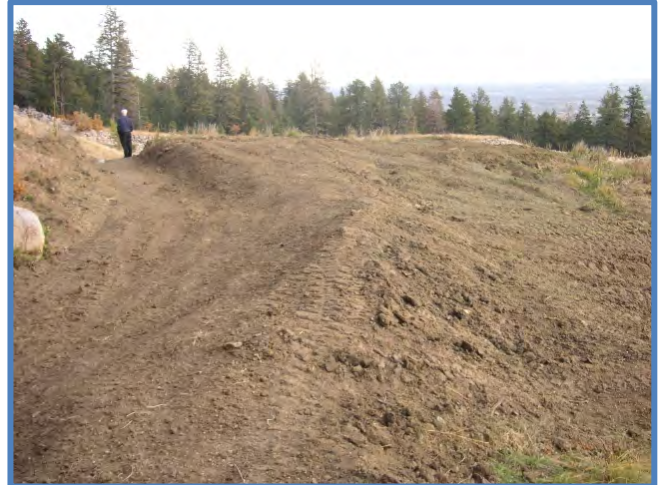
Drainage 24: North Debris Basin. Approximately 12-24 inches of water has been standing in the bottom of the basin since the storm events. A drainage to the southwest of the basin, bypassed the basin and caused erosion to the south of the basin. A berm and swale has been constructed since the storm events, however it appears the north end of the swale is higher than the south.

Action: Repairs Recommended. Determine why water is standing in the bottom. Remove the sediment from the bottom of the basin. Excavate the new swale to drain by gravity with minimal ponding to the debris basin. Revegetate the disturbed areas.
